MAURICE'S CAMPGROUND

6/23/22

Due Diligence Report

DUE DILIGENCE REPORT

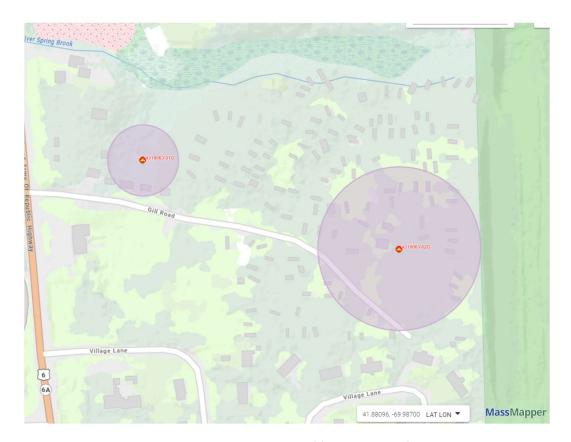
Figure 4 - MassDEP GIS Public Water Supply

As shown above, the site contains (2) two documented public water supply wells (4318063-02G to the East and 4318063-01G to the West which from our understanding is not in use). The system is registered with MassDEP as PWS ID #4318063. Attached in Appendix F please find the most recent compliance/testing documents retrieved from the MassDEP website.
